**DECISION ON SCOPE STUDY FOR
HOMESTEAD/WAKEFIELD ELEMENTARY SCHOOL**

HOMESTEAD/WAKEFIELD ELEMENTARY SCHOOL

HARFORD COUNTY PUBLIC SCHOOLS
February 22, 2021

Harford County Public Schools
Homestead/Wakefield Elementary Schools
Belair, Maryland
Conditions Survey/ Feasibility Study
December 2020

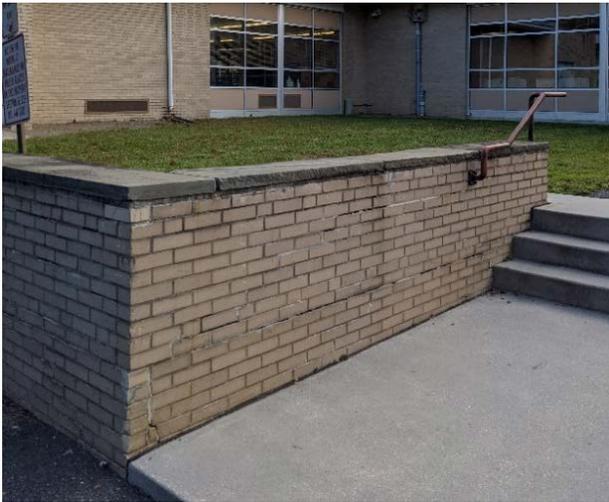
Masonry Site Wall

There is a masonry site wall located near the loading dock area of the Wakefield school. This wall is in fair condition, however, there is some minor cracking that will likely require maintenance or replacement. There is also a timber site wall located between the hard surface play courts and the southeast side of the Homestead building. This wall is also in fair condition and may require maintenance or replacement.

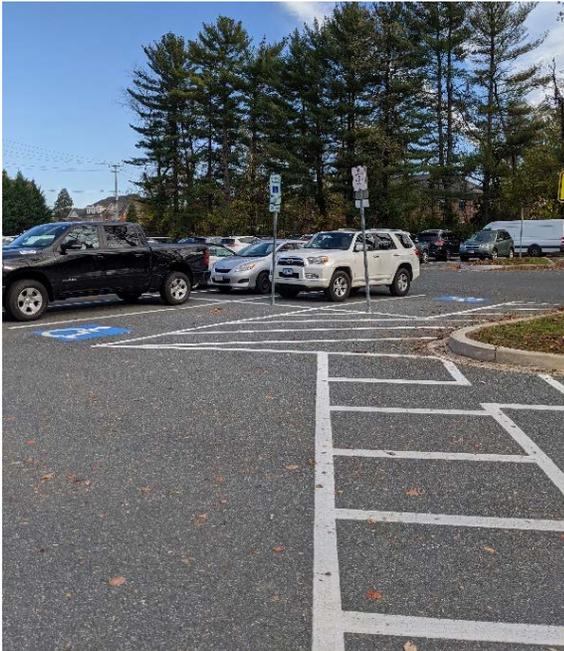
Wakefield Parking

On the northeast side of the Wakefield school building there are 76 marked parking spaces including four (4) handicap accessible spaces. According to the current Code of Maryland Regulations (COMAR), parking lots with a total of 76 to 100 parking spaces are required to have a minimum of four (4) handicap accessible spaces including one (1) van accessible space. The quantities of accessible spaces in both existing parking lots meet the above requirements; however, the spaces are not currently up to code. For instance, some spaces do not have access aisles. Additionally, bollards are recommended for the handicap parking signs to prevent damage.

The asphalt paving is in poor condition in some areas throughout the site and may require replacement. There is cracking and pavement failure in the larger areas of asphalt such as parking lots and major deterioration in areas of asphalt walks. Replacing asphalt walks with concrete is recommended. Additionally, there are areas of curb and gutter that are in poor condition and may require replacement.

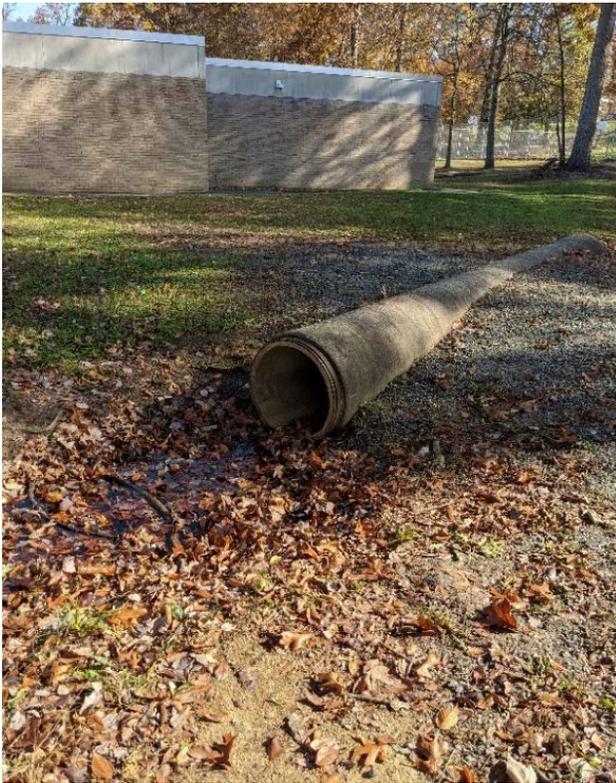
Typical Culvert Pipe lacking cover

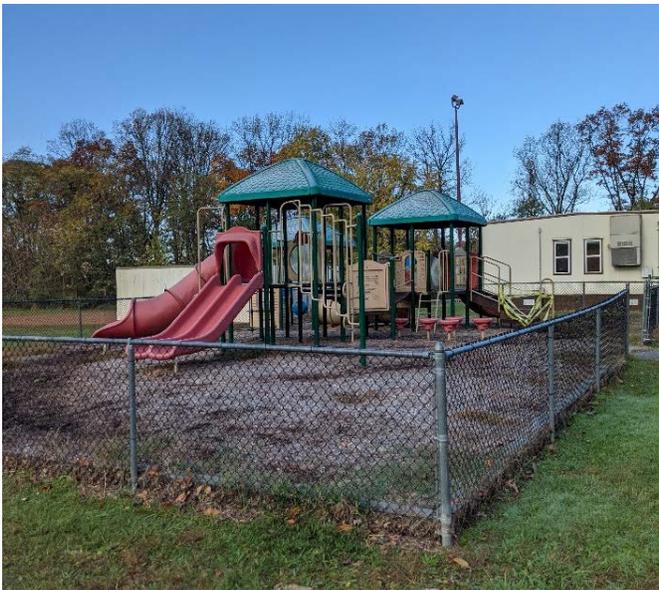
Wakefield Playground

Wakefield building has a total of three (3) and Homestead building has a total of two (2) playgrounds that are located closer to the buildings. Playground equipment and surrounding chain link fence appear to be very old and in poor condition. The playground surfacing is engineered wood fiber and both the surfacing and timber edging needs to be replaced to meet the National Recreation and Park Association (NRPA) and ADA requirements.

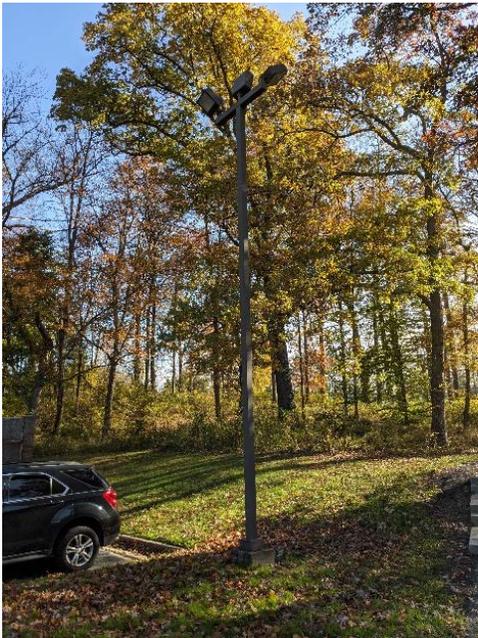
Site Lighting

Site lighting is a primary security consideration, and for this property, there is a limited amount of site lighting throughout the site. Mainly provided within the parking areas. It is recommended that site lighting be provided throughout the site to increase visibility and site security. Security cameras are visibly mounted on multiple locations on the school buildings. It is recommended these cameras be maintained or a new security system installed as part of the proposed development.

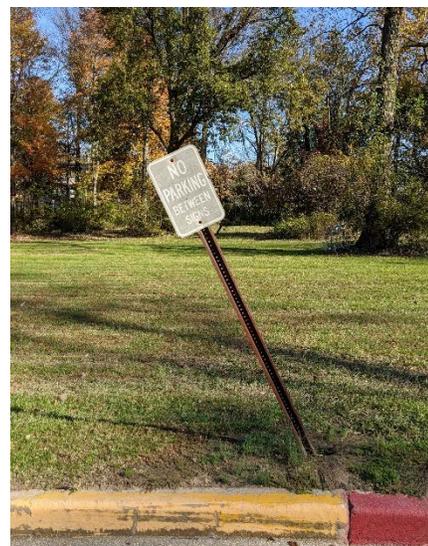
Signage Requiring Replacement

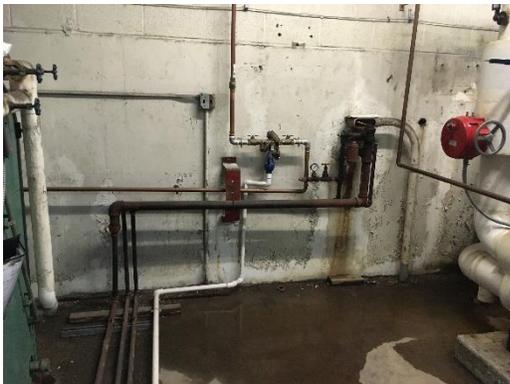
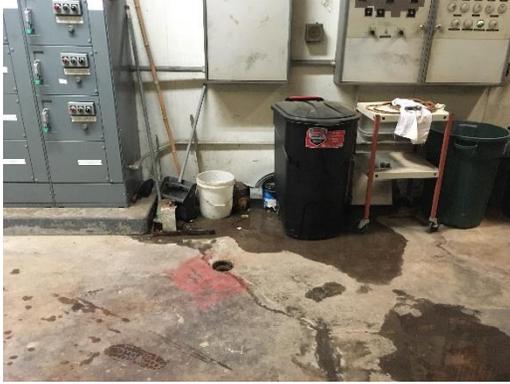
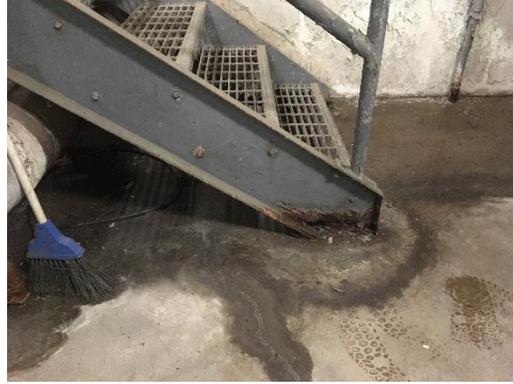
- Water infiltration was noted at the north, east and west walls of the main mechanical room. Water was ponding at several section of the slab. Water was also ponding along the equipment pad that support electrical equipment. The water that ponds on the slab has rusted the ends to the stair stringers in the room.

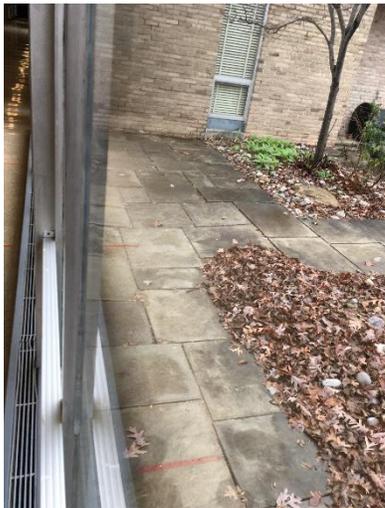
- Settlement of the paving stones at the interior courtyards. This is not structural issue, but the settlement of the paving stones could create tripping hazards.

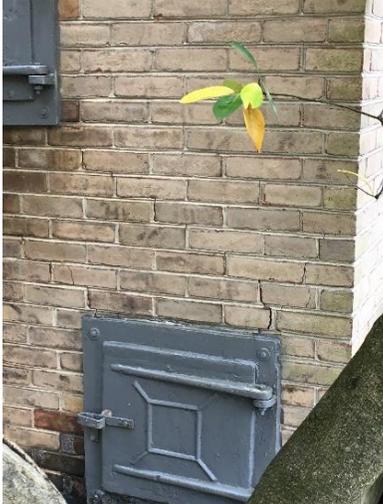
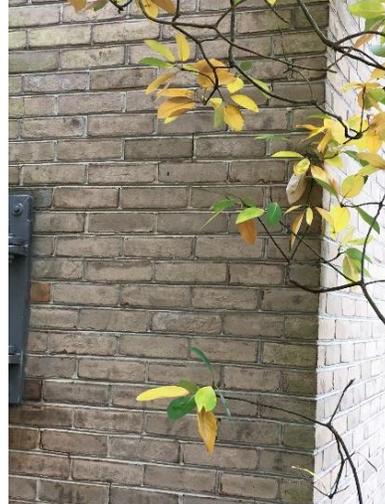
- Cracked masonry at the walls of the boiler stack. These propagate from the corners of the steel access doors. The cracks are probably due to a combination of minor settlement and thermal expansion.

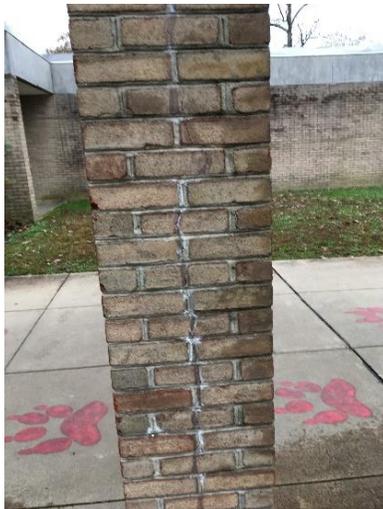
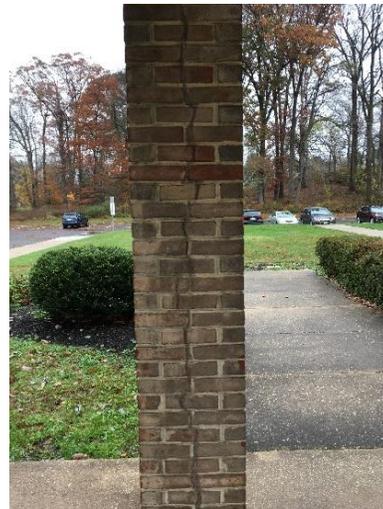
- Cracked piers at the entrance canopy. All the canopy piers have similar cracks. Some of these cracks appear to have been repaired and caulked but the cracks have re-open. There is the possibility that water is getting into the piers which is freezing and cracking the masonry.

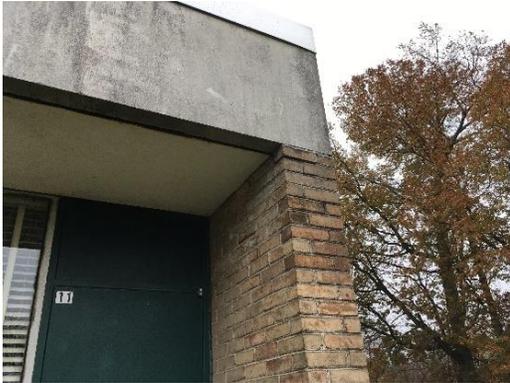
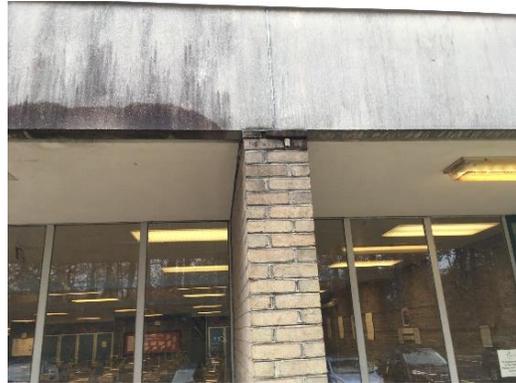
- There are a couple of loose bricks over top of piers at the cafeteria. This is probably due to thermal expansion of the steel members that bear on the masonry piers.

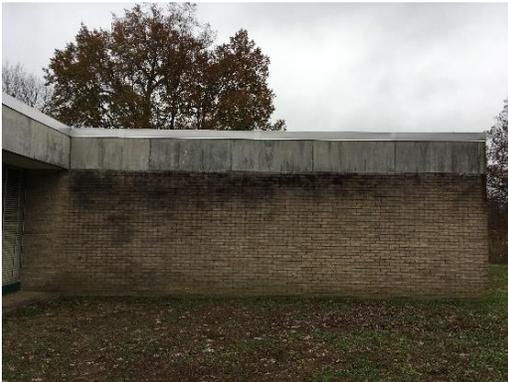
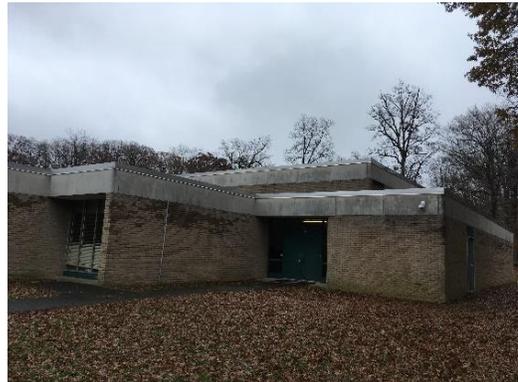
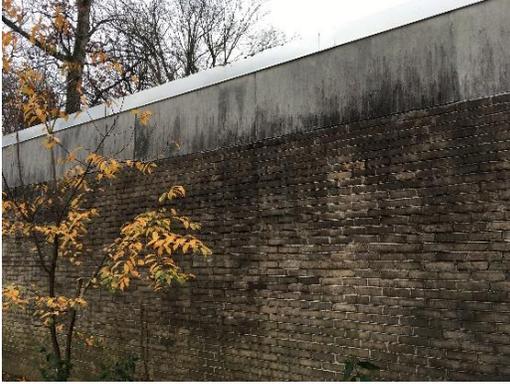
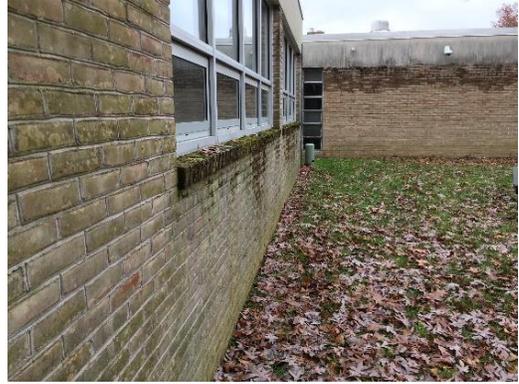
- Typically, there are signs of moisture along the upper sections of most of the exterior walls. The cause of the moisture is unknown, but it could be from water spilling over from the roof.

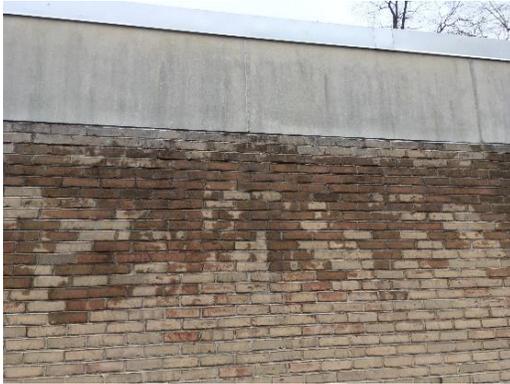
- Damaged and eroded brick joints was noted especially at the top sections of the wall where there is evidence of moisture. The constant moisture has probably softened and has caused the joints to deteriorate.

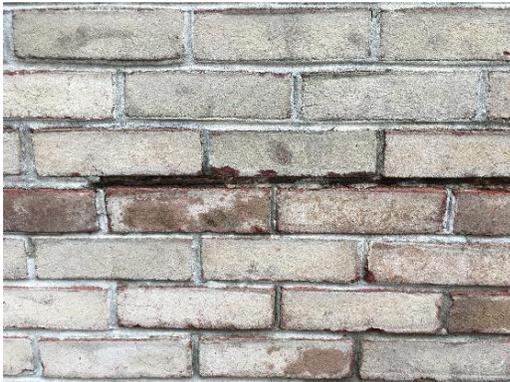
- Some joints have exposed horizontal reinforcing that has begun to rust. This is probably due to the moisture issue. The rusting action causes the reinforcing to expand and crack the mortar in the joints.

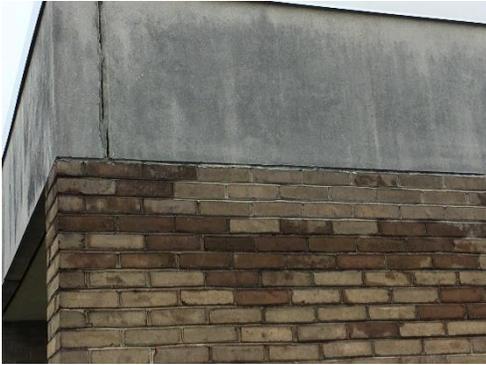
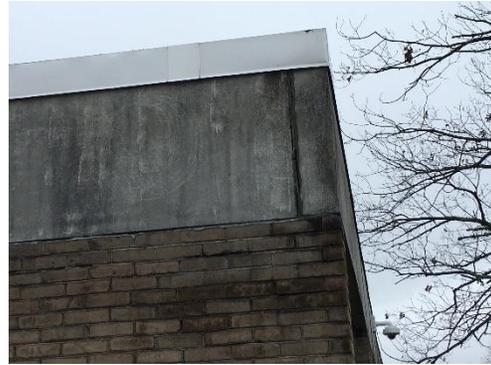
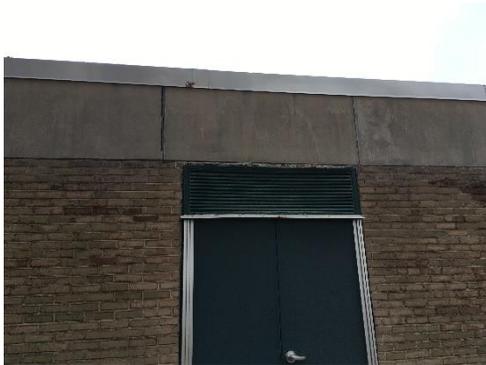
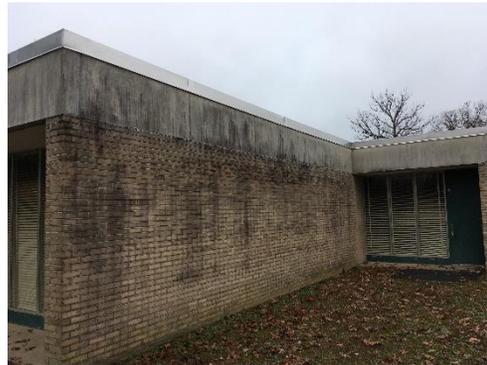
- Cracked, damaged and open caulk joints at the vertical joints between the panels and at the bottom of the panels. The caulk appears to have reached its useful life.

The damage observed during the inspection is mostly due to water infiltration and long term exposure to the elements. The damage has not caused major structural issues but if left unattended will lead to expensive structural repairs.

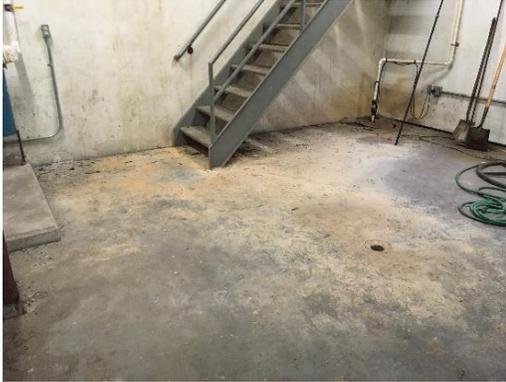
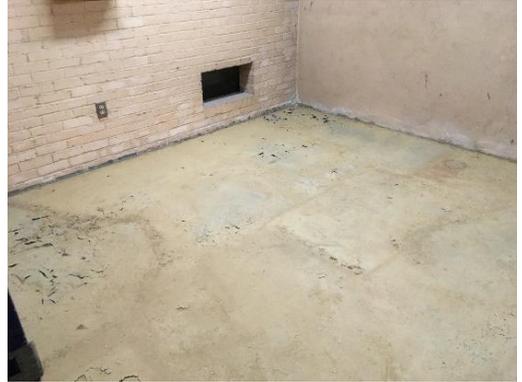
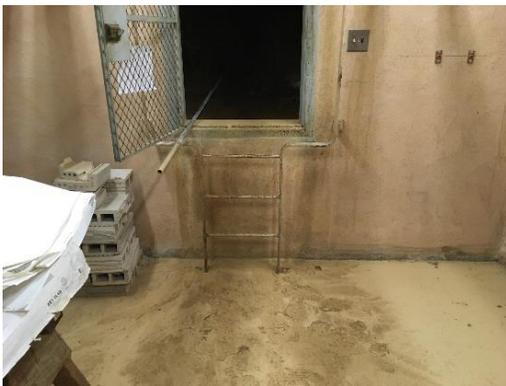
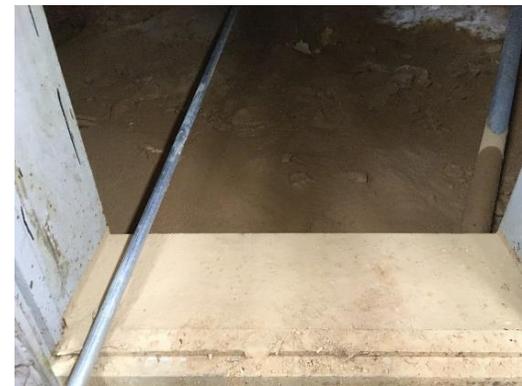
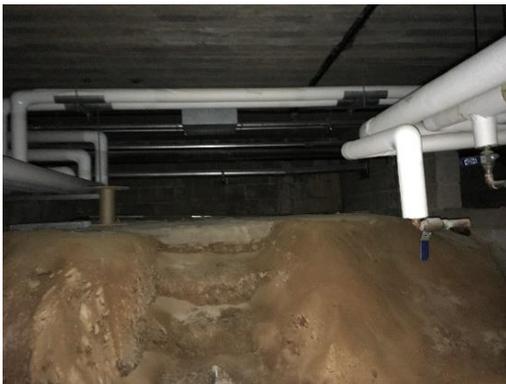
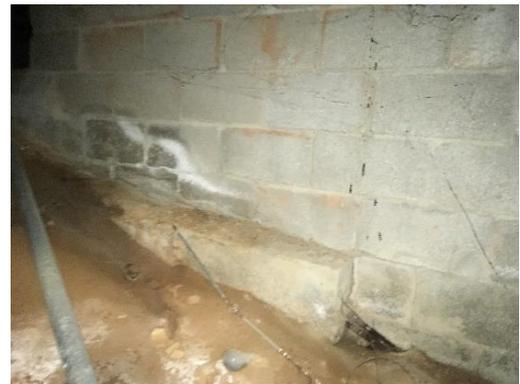
- Dried soil residue was noted against the north wall of the main mechanical room, at the upper mechanical rooms and especially at the room that provides access to the mechanical crawl space. The soil inside the crawl space was found to be wet, saturated and there were signs of water infiltration into the crawl space. It appears that water is seeping thru the exterior wall of the crawl space and that the water is then overflowing into the main mechanical room and draining into one of the floor drains of the mechanical room

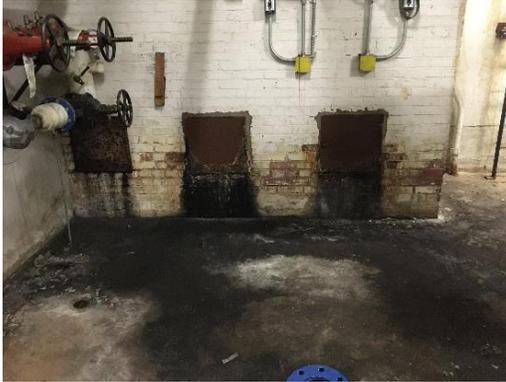
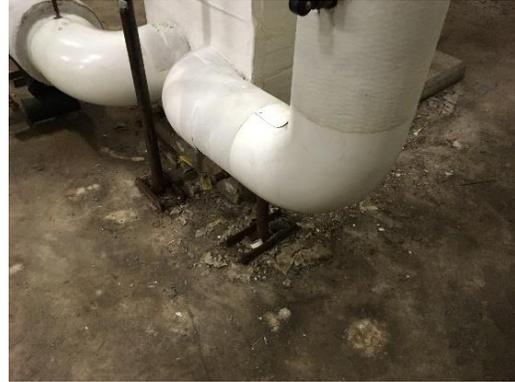
- Signs of water infiltration into the main mechanical room at the bottom of the boiler stack. Water appears to be collecting inside the stack and then coming thru the bottom of the stack wall. The water has begun to rust some of the adjacent pipe supports.

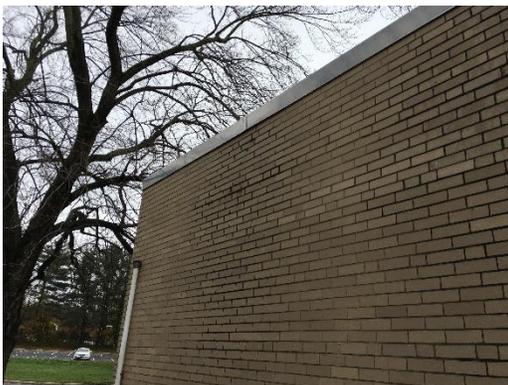
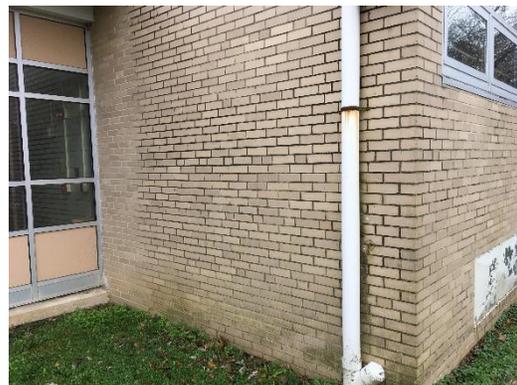
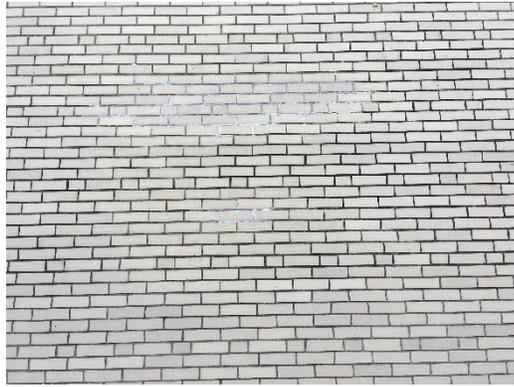
- Minor damage at exterior brick. There is some damage to the brick joints especially where there are signs of constant moisture in the walls.

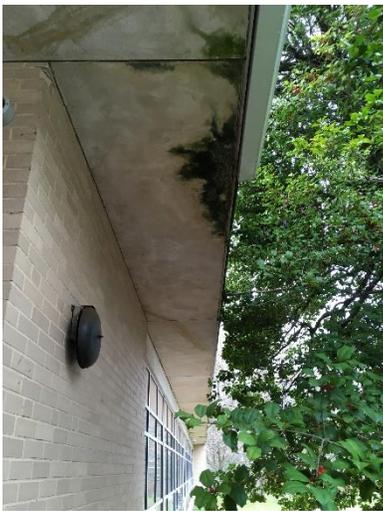
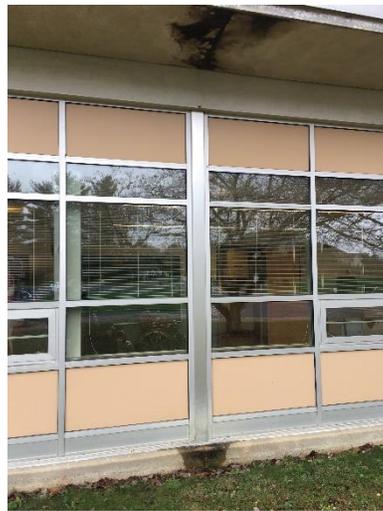
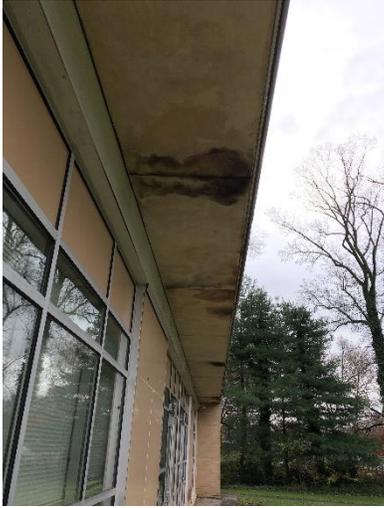
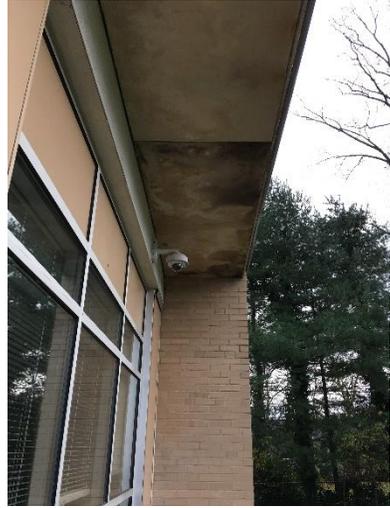
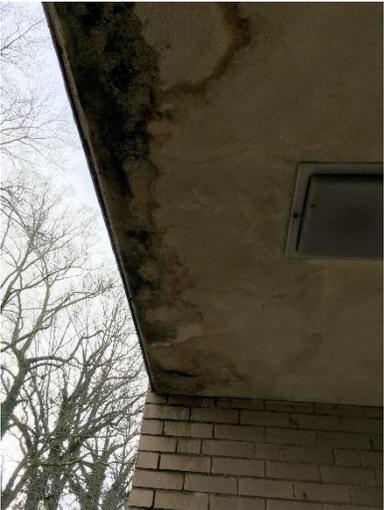
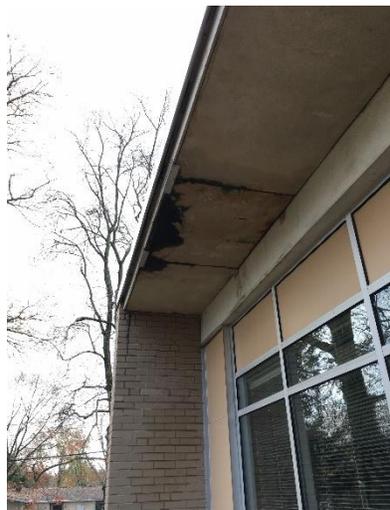
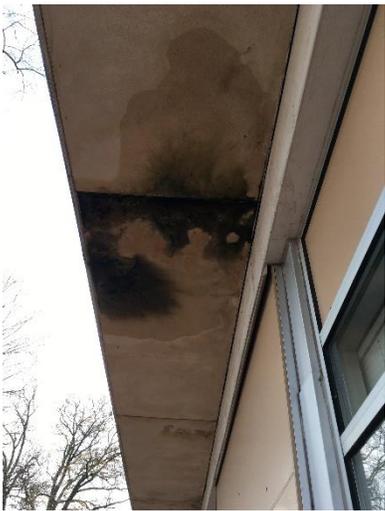
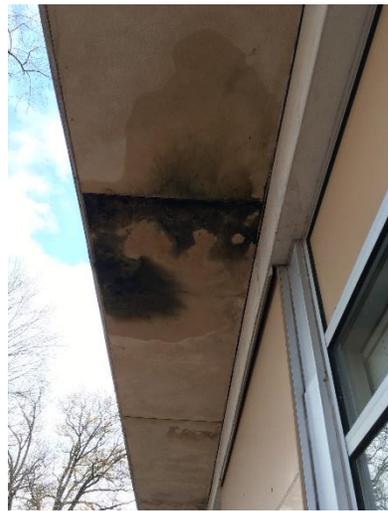
- Water from the roof is spilling over the edge especially at the continuous roof overhangs. The water has soaked the soffits at numerous sections of the overhangs. The constant moisture appears to be causing the growth of mold.

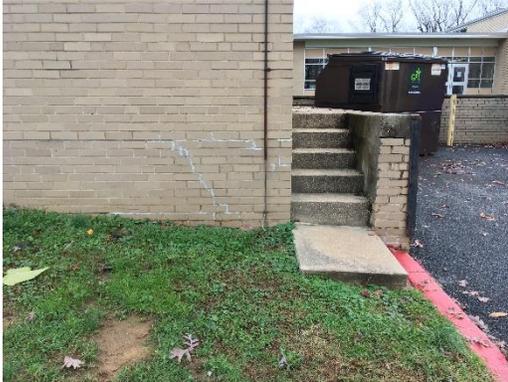
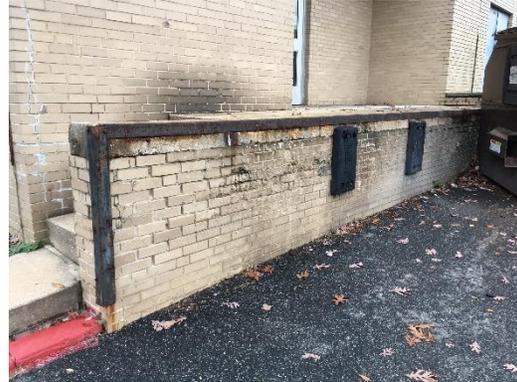
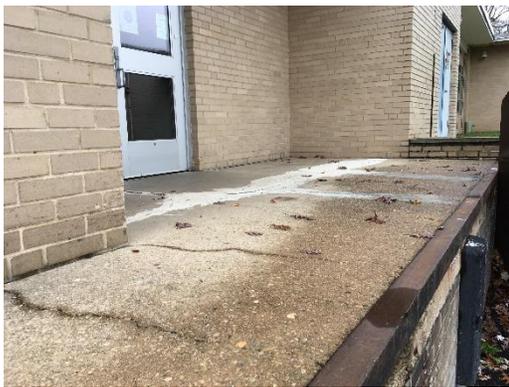
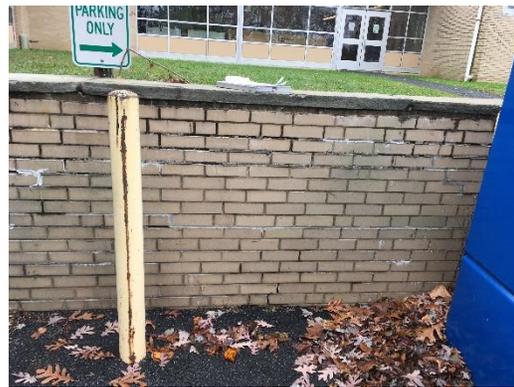
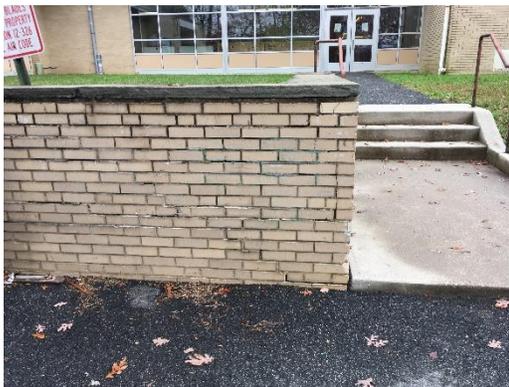
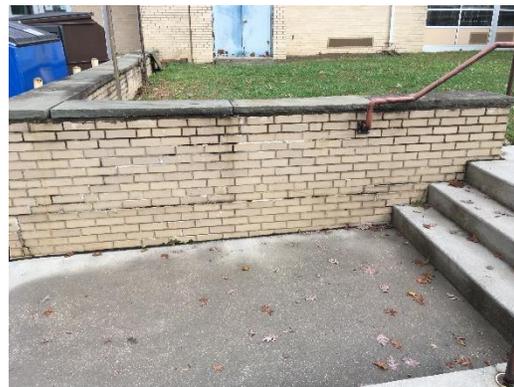
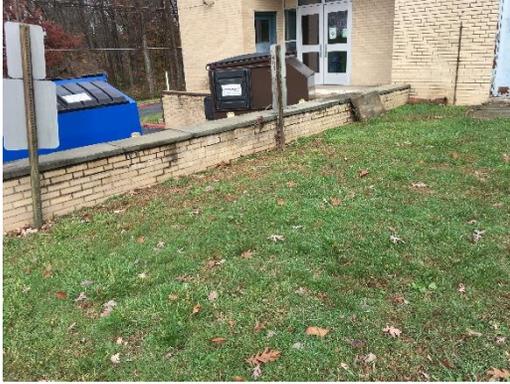
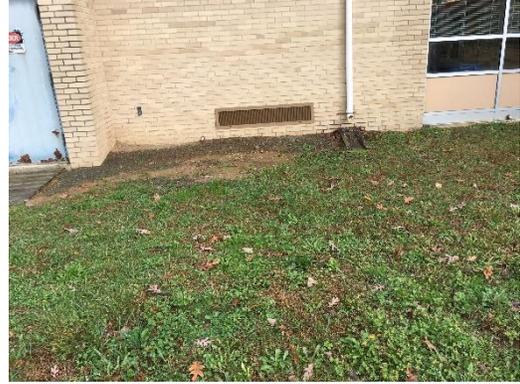
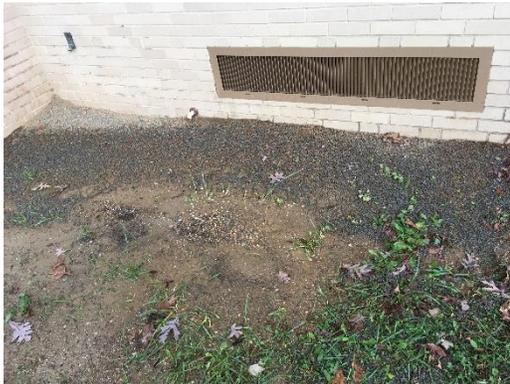
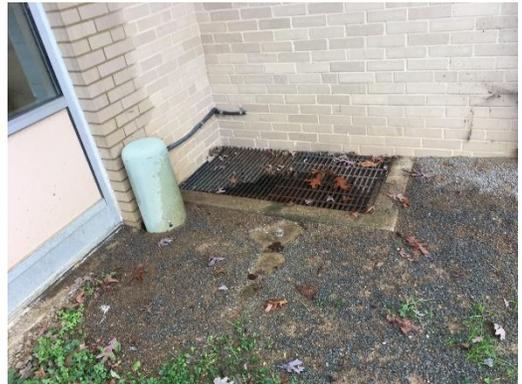
- Cracked exterior walls at the loading dock probably due to settlement. The adjacent loading dock walls and slab have been damaged and severely cracked. The adjacent site walls are cracked and damaged.

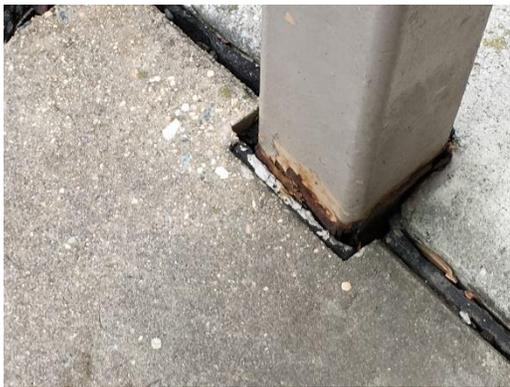
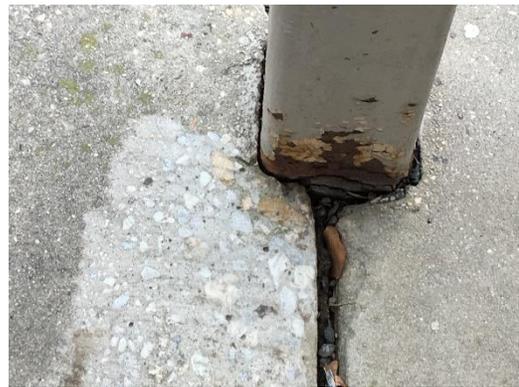
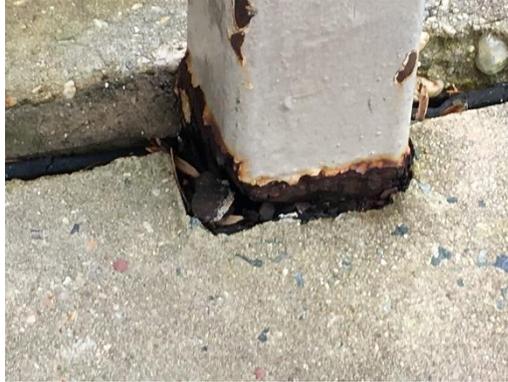
- Rusted entrance canopy columns. The damage is typically at the base of the columns. Some of the rust appears to be completely thru the sides of the columns.

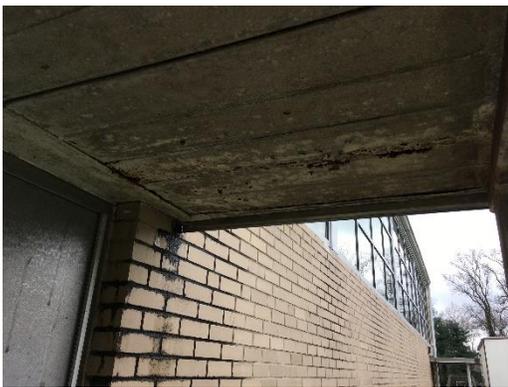
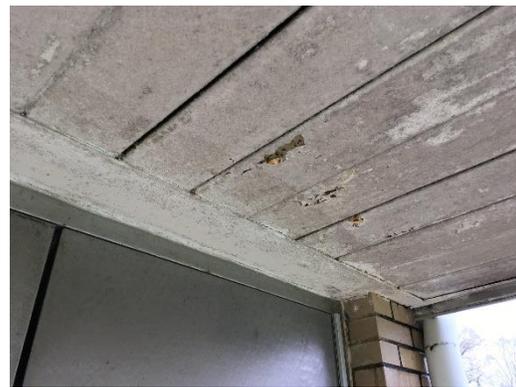
- Rust damage to the metal deck at the small entrance canopies over the exterior doors to the multipurpose room. The rust in some cases has come thru the metal deck.

The damage observed during the inspection is due to water infiltration, long term exposure to water and the elements and due to minor settlement. The damage noted has not caused major structural issues but if left unattended will lead to expensive structural repairs.
