**DECISION ON SCOPE STUDY FOR
HOMESTEAD/WAKEFIELD ELEMENTARY SCHOOL**

HOMESTEAD/WAKEFIELD ELEMENTARY SCHOOL

HARFORD COUNTY PUBLIC SCHOOLS
February 22, 2021

Harford County Public Schools
Homestead/Wakefield Elementary Schools
Belair, Maryland
Conditions Survey/ Feasibility Study
December 2020

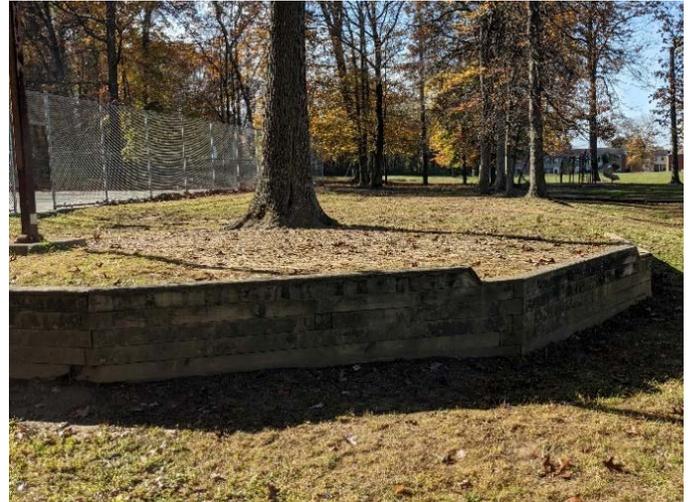
Timber Site Wall

There is a masonry site wall located near the loading dock area of the Wakefield school. This wall is in fair condition, however, there is some minor cracking that will likely require maintenance or replacement. There is also a timber site wall located between the hard surface play courts and the southeast side of the Homestead building. This wall is also in fair condition and may require maintenance or replacement.

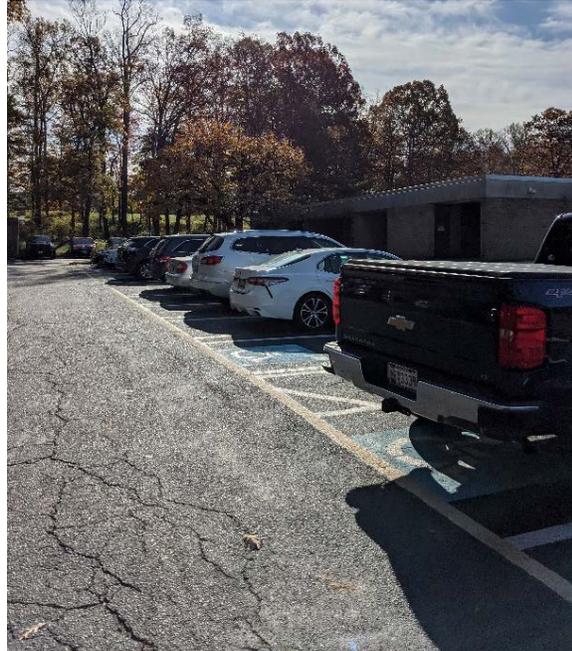
Homestead Parking

The asphalt paving is in poor condition in some areas throughout the site and may require replacement. There is cracking and pavement failure in the larger areas of asphalt such as parking lots and major deterioration in areas of asphalt walks. Replacing asphalt walks with concrete is recommended. Additionally, there are areas of curb and gutter that are in poor condition and may require replacement.

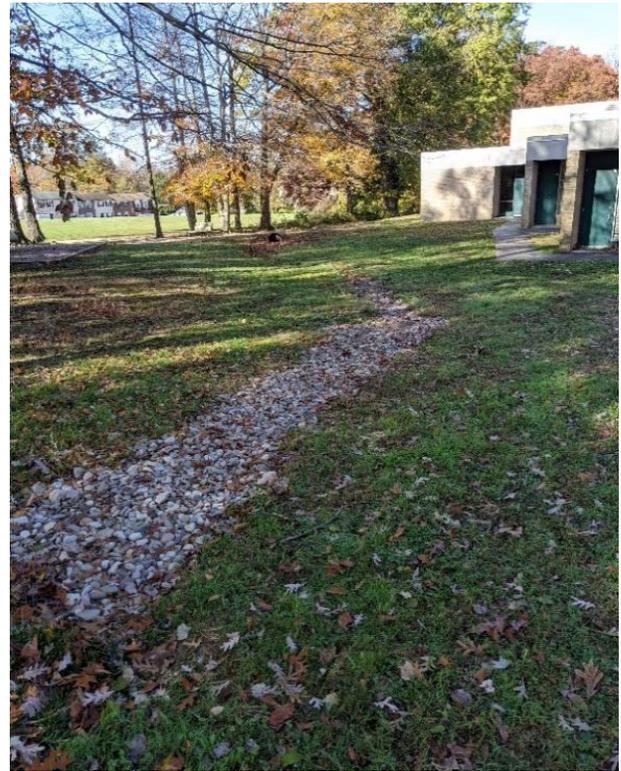
Conveyance of Overland Flow

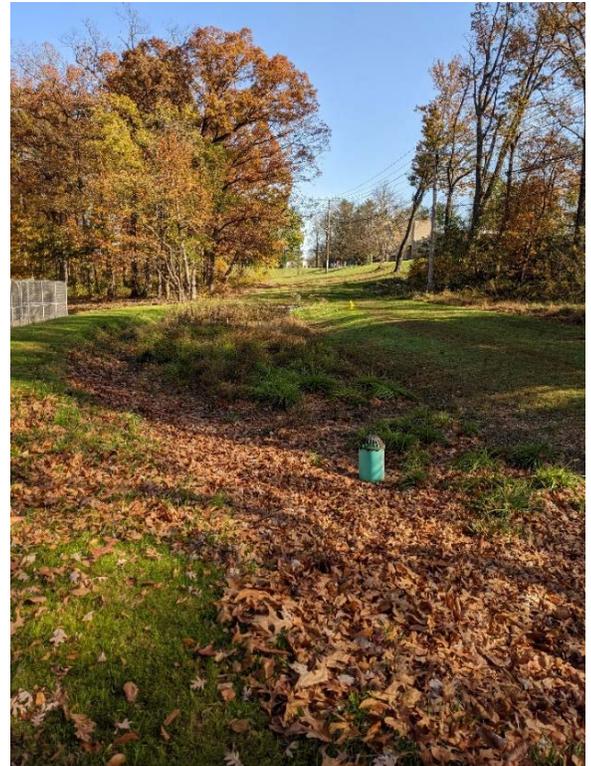
Existing Stormwater Management Facility

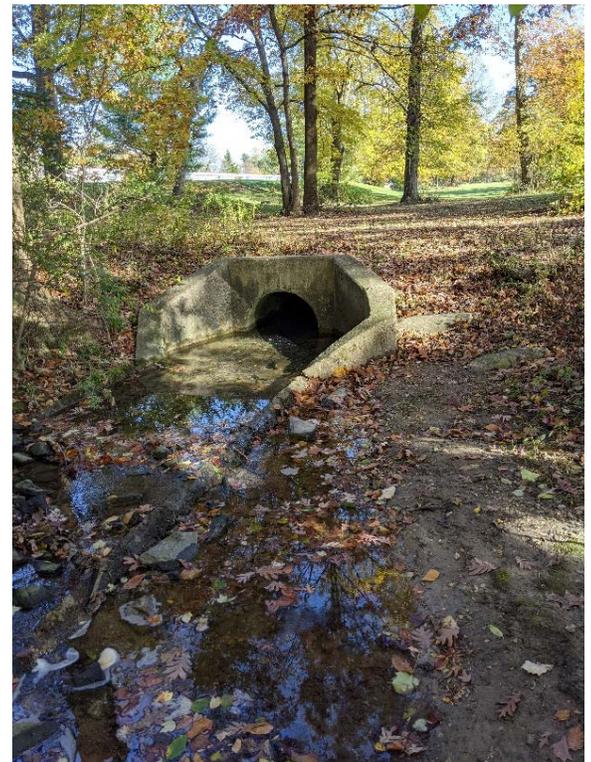
End Wall Outfall into Plumtree Run

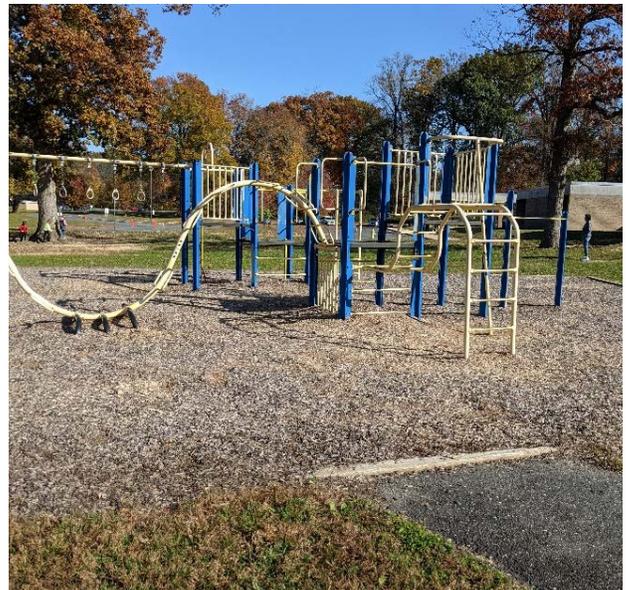
Homestead Playground

Wakefield building has a total of three (3) and Homestead building has a total of two (2) playgrounds that are located closer to the buildings. Playground equipment and surrounding chain link fence appear to be very old and in poor condition. The playground surfacing is engineered wood fiber and both the surfacing and timber edging needs to be replaced to meet the National Recreation and Park Association (NRPA) and ADA requirements.
